## FAILURE OF ALUMINIUM ALLOY ADAPTER IN FATIGUE TESTING

**Vaishakhi Nandi, R. R. Bhat and I.N. Yatisha  
Hindustan Aeronautics Limited (HAL), Bangalore**

### BACKGROUND INFORMATION

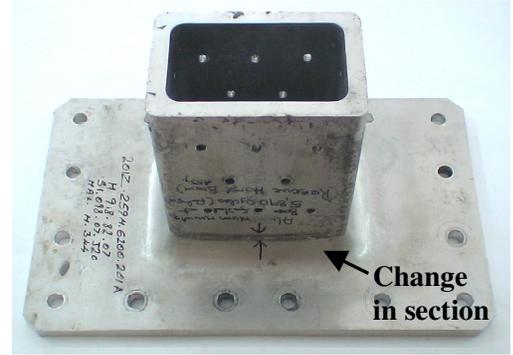
Photograph of the as-received adapter that had failed during the fatigue test is shown in Fig.1. Failure had taken place at a location just above the change in section in the part. Close-up view of the failure location is given in Fig.2. The fillet radius at the change in section did not appear to be very sharp and was having sufficient radius/relief.

**Fig.1:** Photograph of the part adapter that had failed during the fatigue test

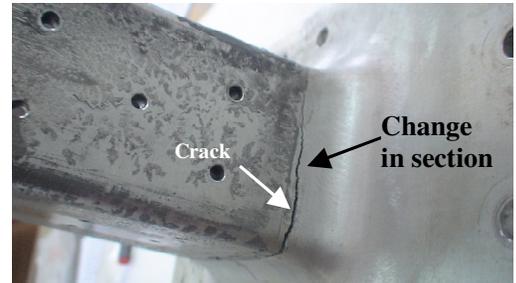
**Figure 2:** Close-up view of the failure location in the adapter

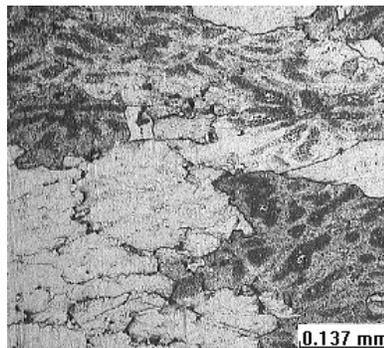
However, microscopic examination revealed presence of remnant cast structure in the microstructure of the adapter material. Photomicrographs showing presence of remnant cast structure in the sample sectioned away from the failure are shown in Fig.3. The sample sectioned close to the failed location revealed significant level of cast/dendritic structure (Fig.4).

Fig.3. Remnant cast structure in the sample sectioned away from the failure

However, micro examination reveal presence of remnant cast structure in the adapter material. Further, at locations close to the failure, the adapter material revealed significant levels of dendritic (cell) structure.

4. The adapter was manufactured from the raw material stock by machining. The raw material used for machining was identified as the source of remnant cast structure in the adapter.
5. The presence of remnant cast structure in the raw material was attributed to insufficient working (viz. extrusion or rolling or forging) of the cast billet that was used to produce the raw material stock. Owing to insufficient working, the cast structure of the billet had not broken down completely. This had resulted in presence of remnant cast (dendritic) structure in the raw material stock that was used to manufacture the adapter.
6. The adapter had cracked at a location just above the change in section (radius) in the part. Fractographic studies revealed that failure in the adapter had

In order to obtain more homogeneous microstructure free from abnormalities like remnant cast structure in the part, it is recommended to manufacture the adapter by forging route rather than direct machining from raw material stock or ensure that the raw material used for machining is free from any cast structure

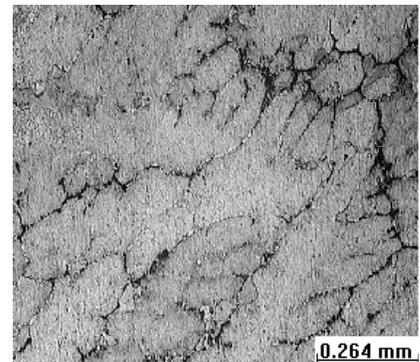
Fig.4: Significant level of cast structure in the sample sectioned close to the failure in the adapter.

7. In principle, for a given metallic material, completely worked structure is believed to have better dynamic properties especially fatigue when compared to that of cast structure. Hence, from the observations and with the available evidences, it looked apparent that the remnant cast (dendritic) structure observed in the adapter material has resulted in its premature failure during the fatigue test.

Remnant cast (dendritic) structure observed in the adapter material appears to have caused the unexpected failure of the

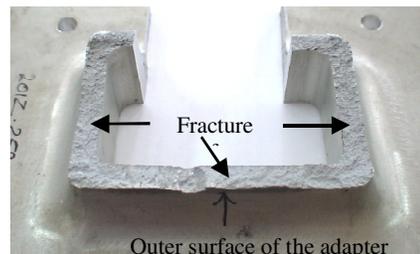
**Fig. 5:** Fracture surface obtained after opening the crack in the adapter

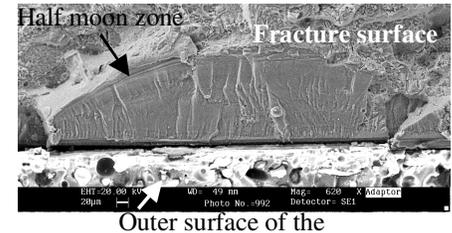
Macro examination had revealed features of fatigue failure on the fracture surface at locations close to the outer surface of the adapter. Hence, the fracture surface close to the outer surface of the adapter was carefully examined under SEM. SEM analysis revealed presence of half moon zones at many locations on the fracture surface. Half moon zone is indicative of fatigue failure. SEM images showing half moon zone on the fracture surface at

locations close to the outer surface of the adapter are given in Fig.6.

**Fig.6:** SEM images showing presence of half moon zones on the fracture surface at locations close to the adapter outer surface

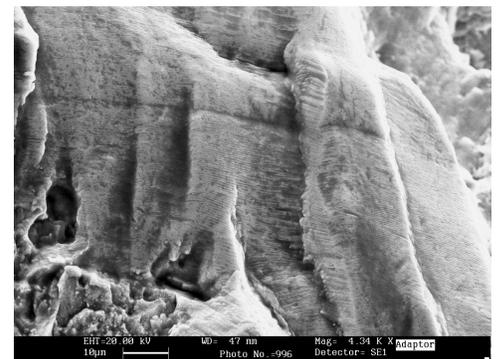
The areas of the fracture surface showing half moon zones revealed presence of striations when examined under SEM at high magnifications. Striations are typical of fatigue failure. High magnification SEM images showing presence of fatigue striations on the fracture surface of the adapter are given in Fig.7.

**Fig.7:** High magnification SEM images showing presence of fatigue striations on the fracture surface of the adapter

The half moon zones and orientation of the fatigue striations confirm the fact that small fatigue cracks had initiated at multiple locations from the outer surface of the adapter.

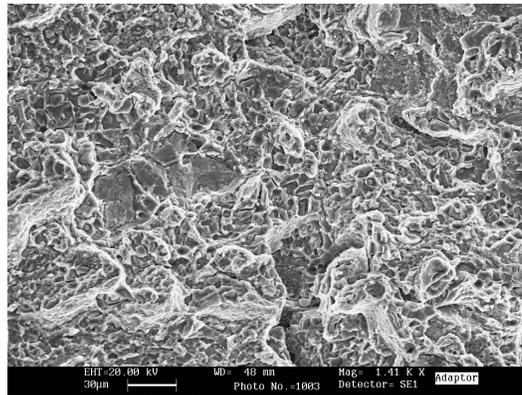
Rest of the fracture surface revealed dimpled features (Figure 8) that is indicative of overload failure and corresponds to the fast/final failure of the adapter.

**Fig. 8:** High magnification SEM image showing presence of dimpled overload features on the fracture surface of the adapter
