# Journal of Materials, Manufacturing & Failure Analysis for Structural Integrity

# Failure Analysis of Car Crankshaft

**Abstract**—The root cause analysis of a prematurely failed crankshaft of a car engine is reported. The micro, macro & fractography of failed surface was conducted using SEM. Assuming that transition from journal to web is properly designed, it is suspected that crack initiation might be due to improper material or poor machining (chatter marks) in the oil drilled hole that may cause stress concentration where cracks may initiate and propagate to fracture by fatigue. The steps to mitigate such failures in SG iron is suggested

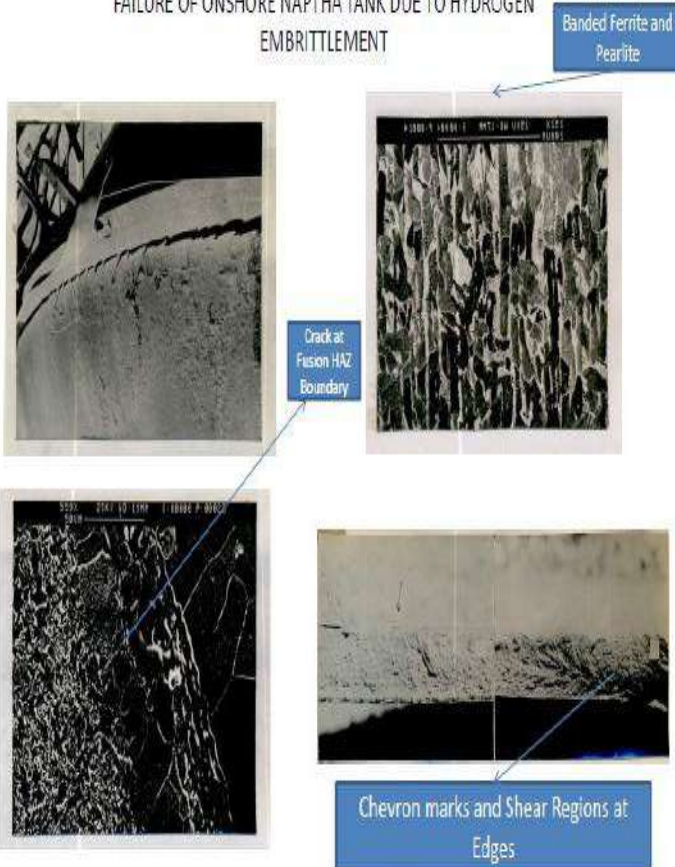
## FAILURE OF ONSHORE NAPTHA TANK DUE TO HYDROGEN EMBRITTLEMENT

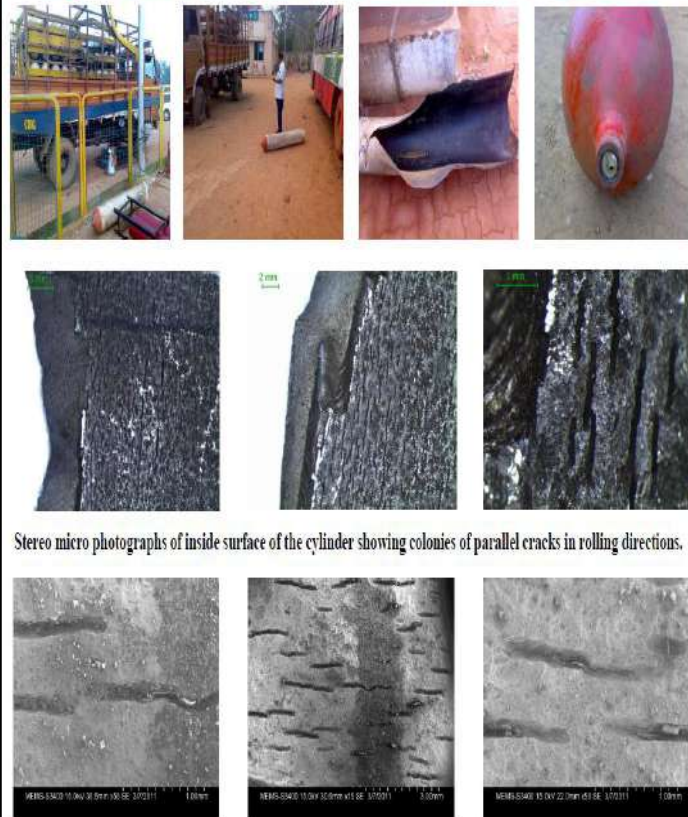
## Hydrogen Embrittlement Failure of CNG Cylinder

High magnification SEM fractographs reveal that cracks initiate, grow and coalesce.

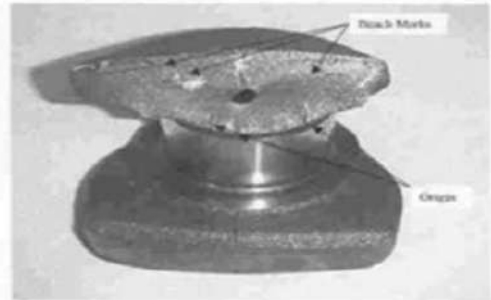
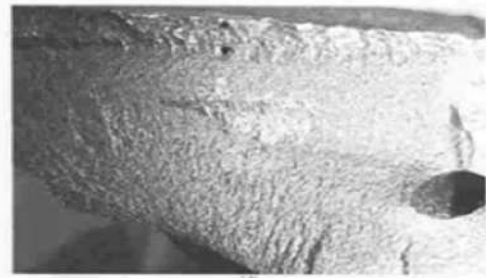
- 1) The fracture surface of the failed crankshaft is shown in Fig 3(a-d). The arrows in the figures show the points from which the failure appears to have originated.

- 2) These points are located at the journal fillets at different levels. When this crack merge they create a cliff wall that appears like chevron marks that point towards the origin (transition region of fillet).

- 3) The fracture that started from fillet has typical; appearance of beach (shell) marks. The beach marks are produced by cyclic loading and periods of rest normally experienced by crankshaft in service.

- 4) These beach marks travel through rifle drilled oil hole and are intercepted by chevron marks. These holes are produced by gun drilling and were found to contain surface defects.

- 5) When fatigue cracks grow to considerable length, the area remaining intact becomes small, leading to overload fracture as shown in Fig 3(d).
- 6) Since the transition from journal to web is properly designed and tooled, it is suspected that initiation might be either due to improper material with low fracture toughness are due to poor machining which initiates crack that propagate to failure by fatigue.

Fig. 3(a & d): Fracture surface of failed crankshaft. Beach Marks travel through rifle drilled oil hole and are intercepted by chevron marks (c). Final overload fracture as indicated by arrow can be seen in (d).

Steps may be taken to avoid surface discontinuity during machining that may cause stress concentration sites from which cracks initiate and propagate to failure by fatigue.

Austempered ductile iron which has high strength and fracture toughness as well as fatigue crack growth resistance may be considered as a substitute material.

Fatigue strength may further be imparted by providing residual compressive stress at the surface.

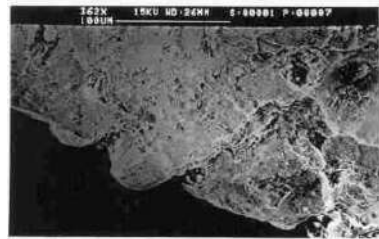
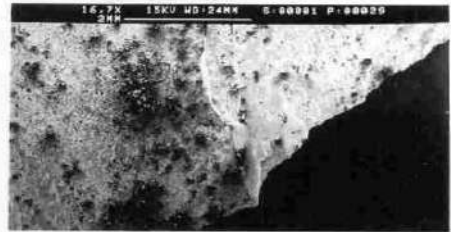
In order to investigate the cause of the failure the failed crankshaft was examined under SEM. The failure initiated at transition region from groove that contained surface discontinuities Fig 4 (a - e) and progressed in the web region. The nodular structure here is not a defect, still the nodule separated region resulting from machining can act as a potential stress raiser site Fig 4(b). A number of secondary cracks and porosities are also seen Fig 4 (f - g). in addition to secondary cracks, porosities, nodule separation at the matrix interface can be seen in fig 4 (h & i). For material like SG iron having lower toughness these sites can very well act as stress raiser from where cracks can originate. Fig 4 (h & i) show separation of nodule at the matrix interface along with secondary cracks and porosities. The micro fractography of the failed web region show striations (feather marks) in addition to nodule separation (j & k).

Fig. 4. Fractograph of the failed crankshaft shows that failure initiated from transition region from grooves that contained surface discontinuities (a-e) and progresses in the web region.

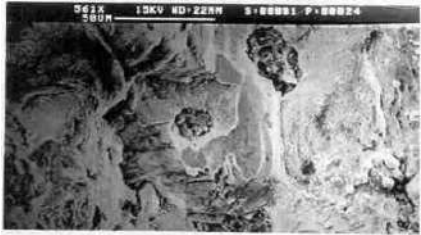
Fig. 4. Fractograph of failed crankshaft shows a number of secondary cracks, porosities and nodule separation at the matrix interface (h & i).

Fractograph of failed crankshaft shows a number of secondary cracks, porosities and nodule separation at the matrix interface (h & i).

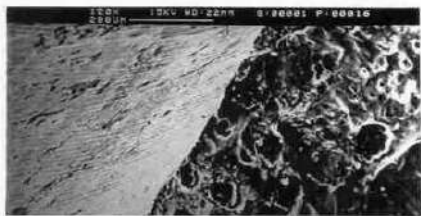
A closure examination of the oil hole by SEM reveals that smooth zones are followed by chatter marks (stress concentration sites). deep grooves at nodules and at interfaces are clearly visible Fig 4 (i - l).

Fig. 4. Closer examination of the oil hole by SEM reveals that smooth zones are followed by chatter marks (stress concentration sites). Deep grooves at nodules and at interfaces are clearly visible (l-n).
